Hairline Cracks in Sand Casting Disappear in Permanent Mold Process

A CASE STUDY

Batesville Products, Inc.

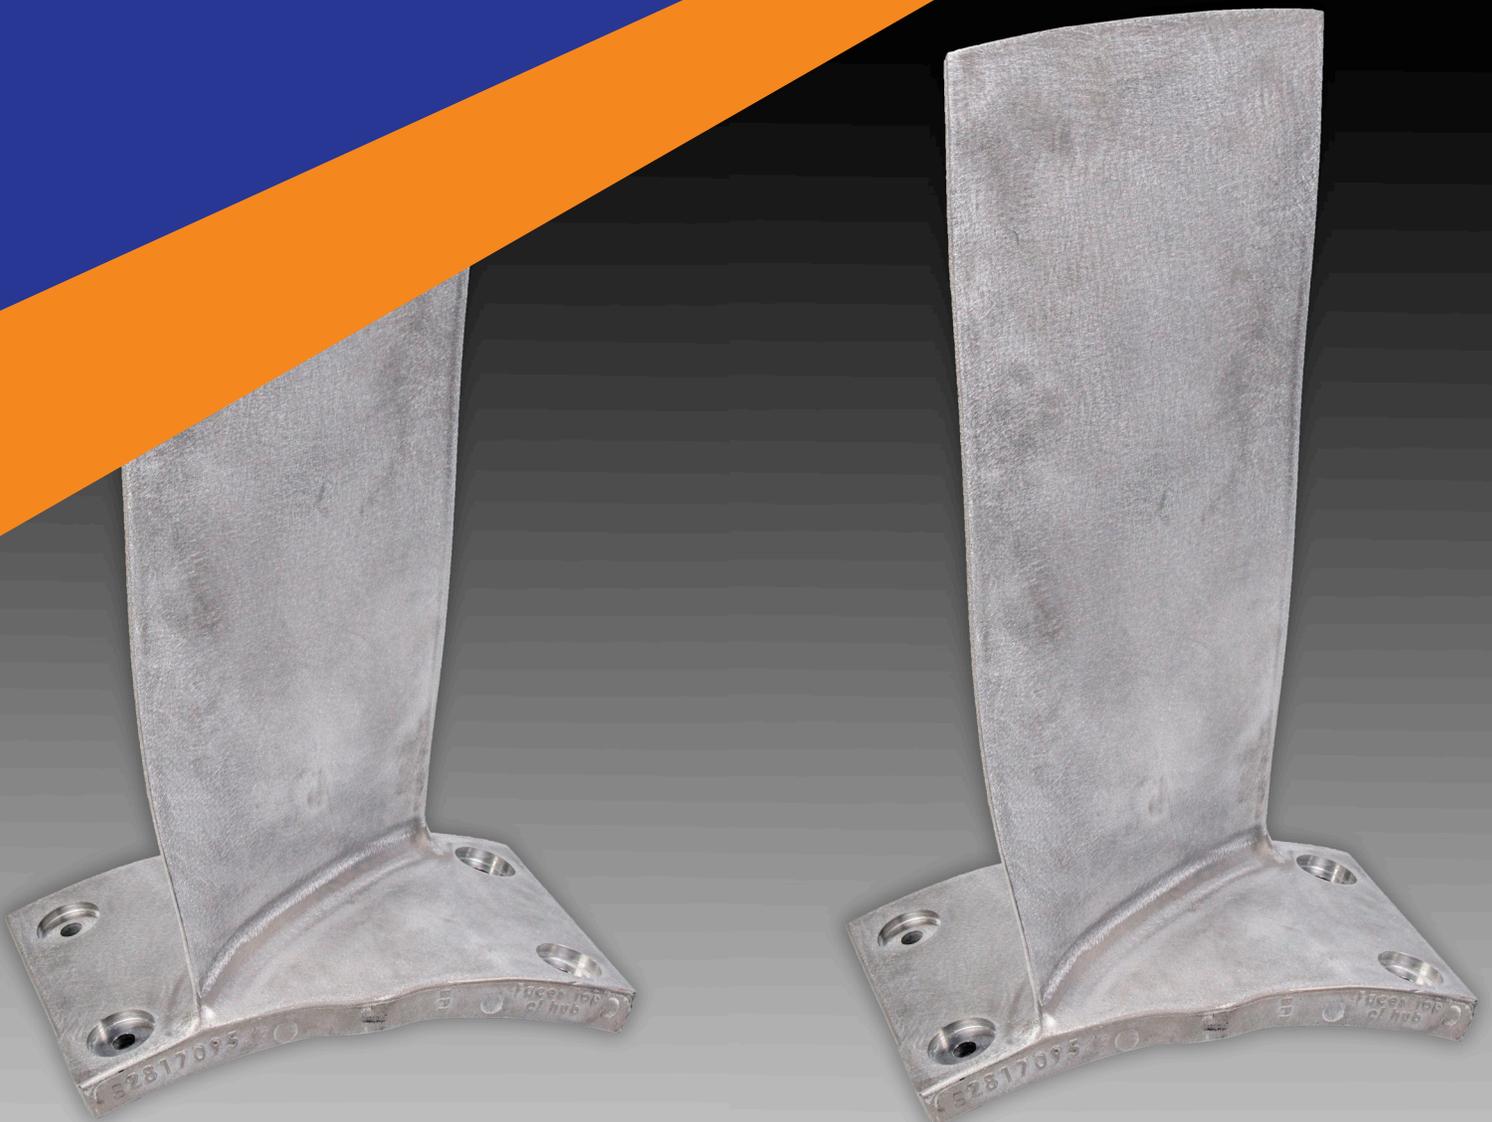
This customer is in the transportation industry, requiring pieces like this blade of a **72-inch** locomotive fan.

The customer came to us because they were experiencing issues with their current supplier. The part was being **sand casted**, and the customer was receiving parts with **hairline cracks** where the base meets the blade.

Turbulence in the metal flow during sand casting caused hairline cracks. By performing a **Finite Element Analysis (FEA)** and implementing a **tilt-pour** method, we identified the best way to cast the part with as little turbulence as possible.

While the sand foundry was casting from the tip, we **flipped the mold upside down** and fed the molten metal through the thick base.
